SOUTHLAND
DISTRICT COUNCIL

Stormwater

2021-2031 Activity Management Plan

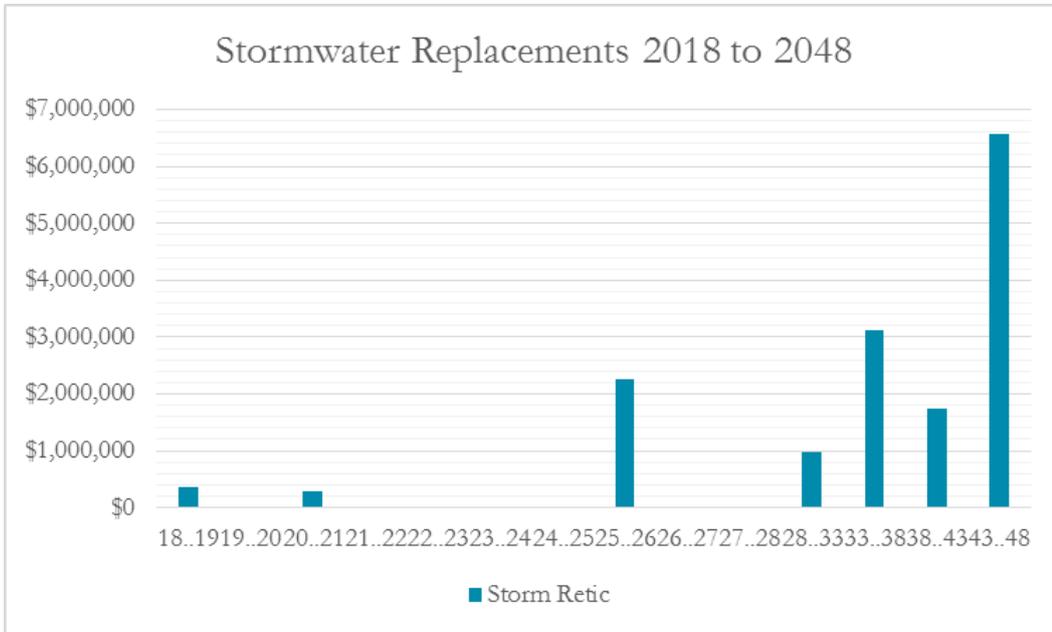
Figure 1: Stormwater Replacements 2018 to 2048

The graph below highlights expected capital expenditure and renewals dates for stormwater reticulation across the District based on current expected asset life and level of service expectation. Where differences occur between planned renewals data in Infor (IPS) and capital expenditure planned in the LTP this is generally at the request of the governing board or based on local knowledge and to date, community affordability, however this will continue to be reviewed as Council moved to a district funded approach.

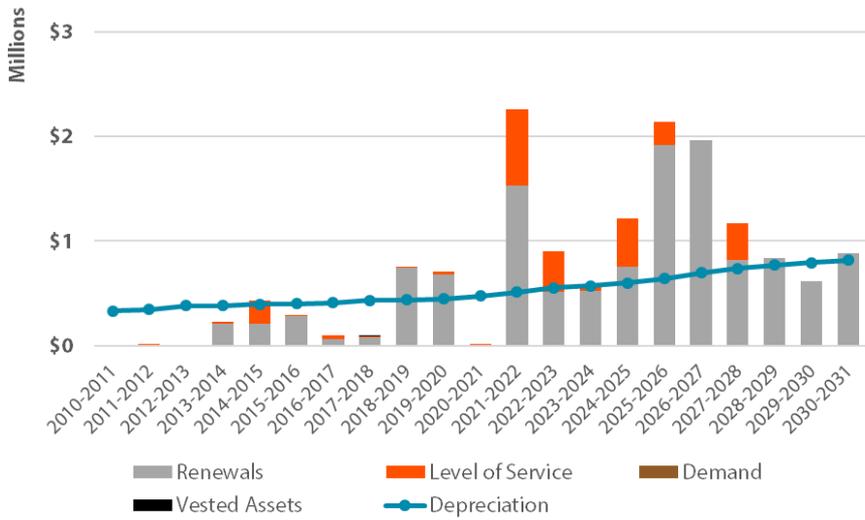
Figure 2: Stormwater Capex Depreciation comparison

The following graph compares the capital expenditure to depreciation. There are some years where the capital expenditure is greater than depreciation largely as a result of historic deferral or maintenance and renewals. Affordability will be an issue for many communities when the assets need to be replacement or there is a higher cost due to regulatory requirements.

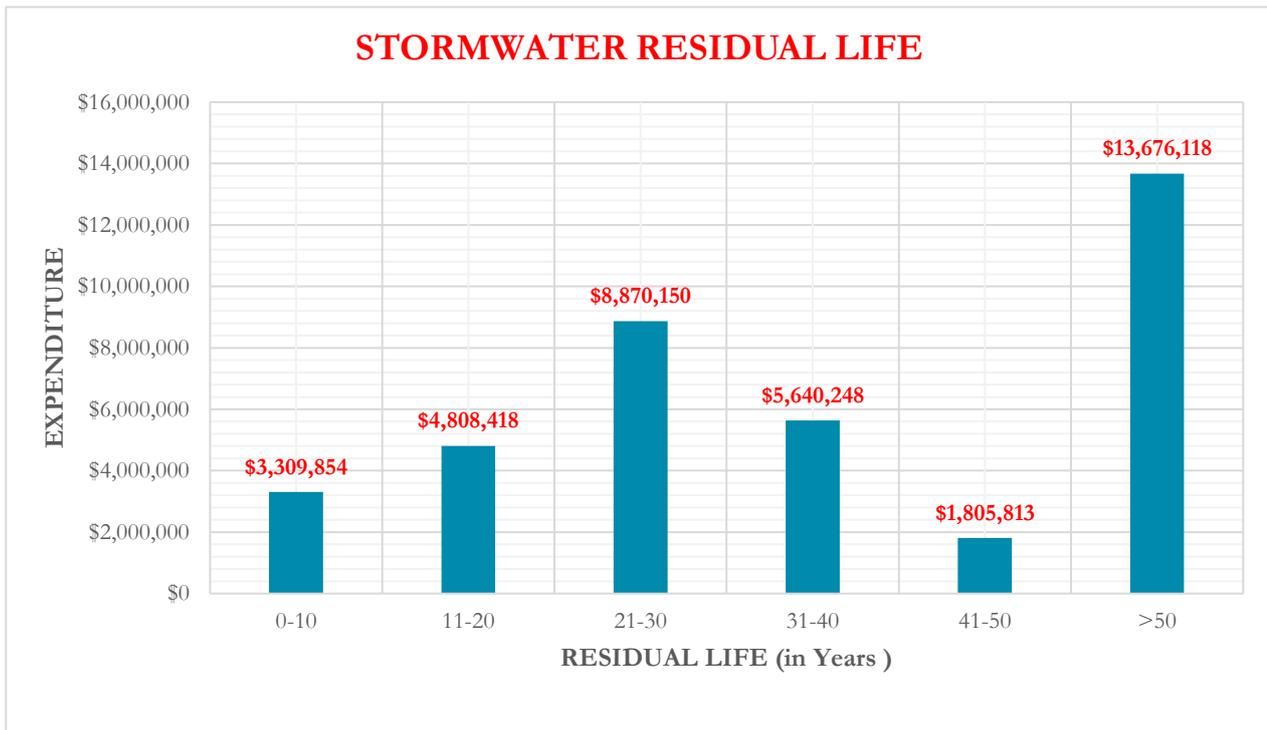
Figure 7: Stormwater residual life

Based on these projected lives the following graph provides an indication of expected remaining lives of all stormwater network infrastructure

Based on these expected lives and the known age of networks across the district it is apparent that it is appropriate to consider a step change in capital investment required to replace these ageing assets and maintain the current levels of service. This is particularly relevant in older townships including Winton and Wyndham where the oldest infrastructure dates back to the 1930s, and should therefore be considered as aged and therefore ready for replacement.

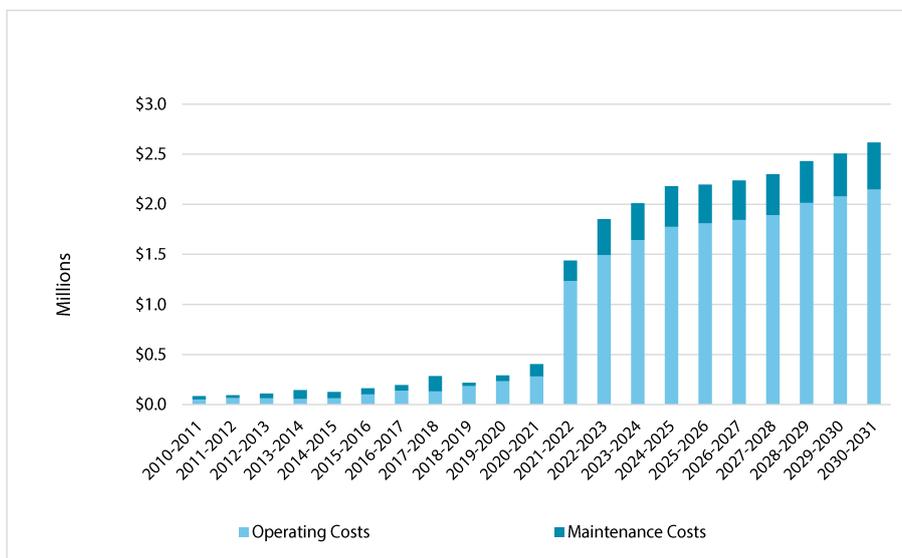
Figure 8: Stormwater Opex Forecasts

Figure presents the 10 year O&M forecasts. O&M costs in the future will rise because of the requirement to meet discharge consent conditions, increased planned maintenance and additional condition assessments across all networks that are yet to be finalised.

Operating costs increase in through the life of the plan. This is in response to the need for an increased level of planned maintenance and investigation work to help develop a fuller understanding of the age and condition of stormwater assets.

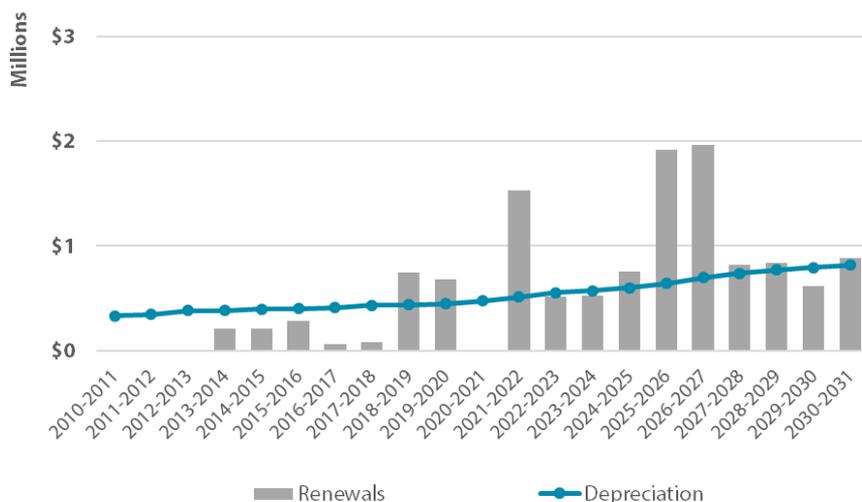
Figure 9: Stormwater Renewal Forecasts (showing depreciation)

The following graph shows capital expenditure trends and forecasts over the past ten years and the next 10 years for renewals.

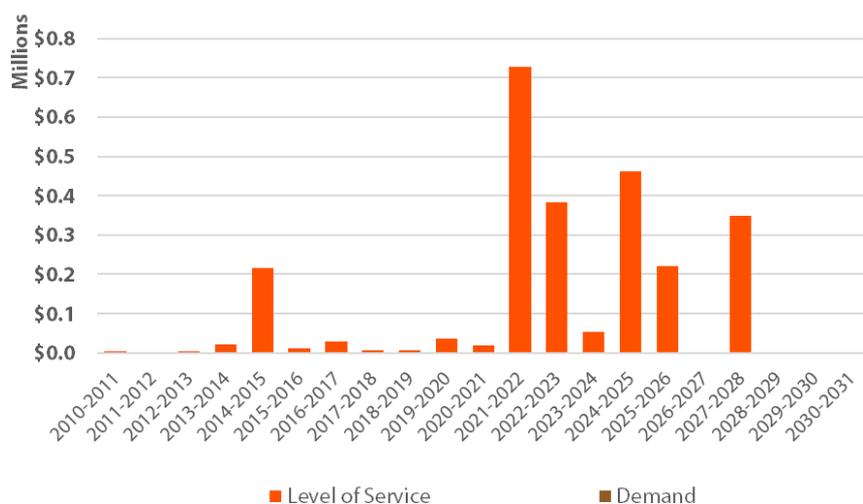
Figure 10: Stormwater LoS and Demand Forecasts

There are amounts forecasted in Winton and Te Anau to allow for improvements required due to consent conditions.

LOS expenditure across individual schemes is illustrated in
